**U.S. CUSTOM HOUSE FLOOR PLANS
BASEMENT**

**WET GYPSUM WALLBOARD (GWB)
2/11/09**

FLOOR PLAN - BASEMENT
U.S. CUSTOM HOUSE
PORTLAND, OREGON

APPENDIX C
PHOTOGRAPHIC LOG

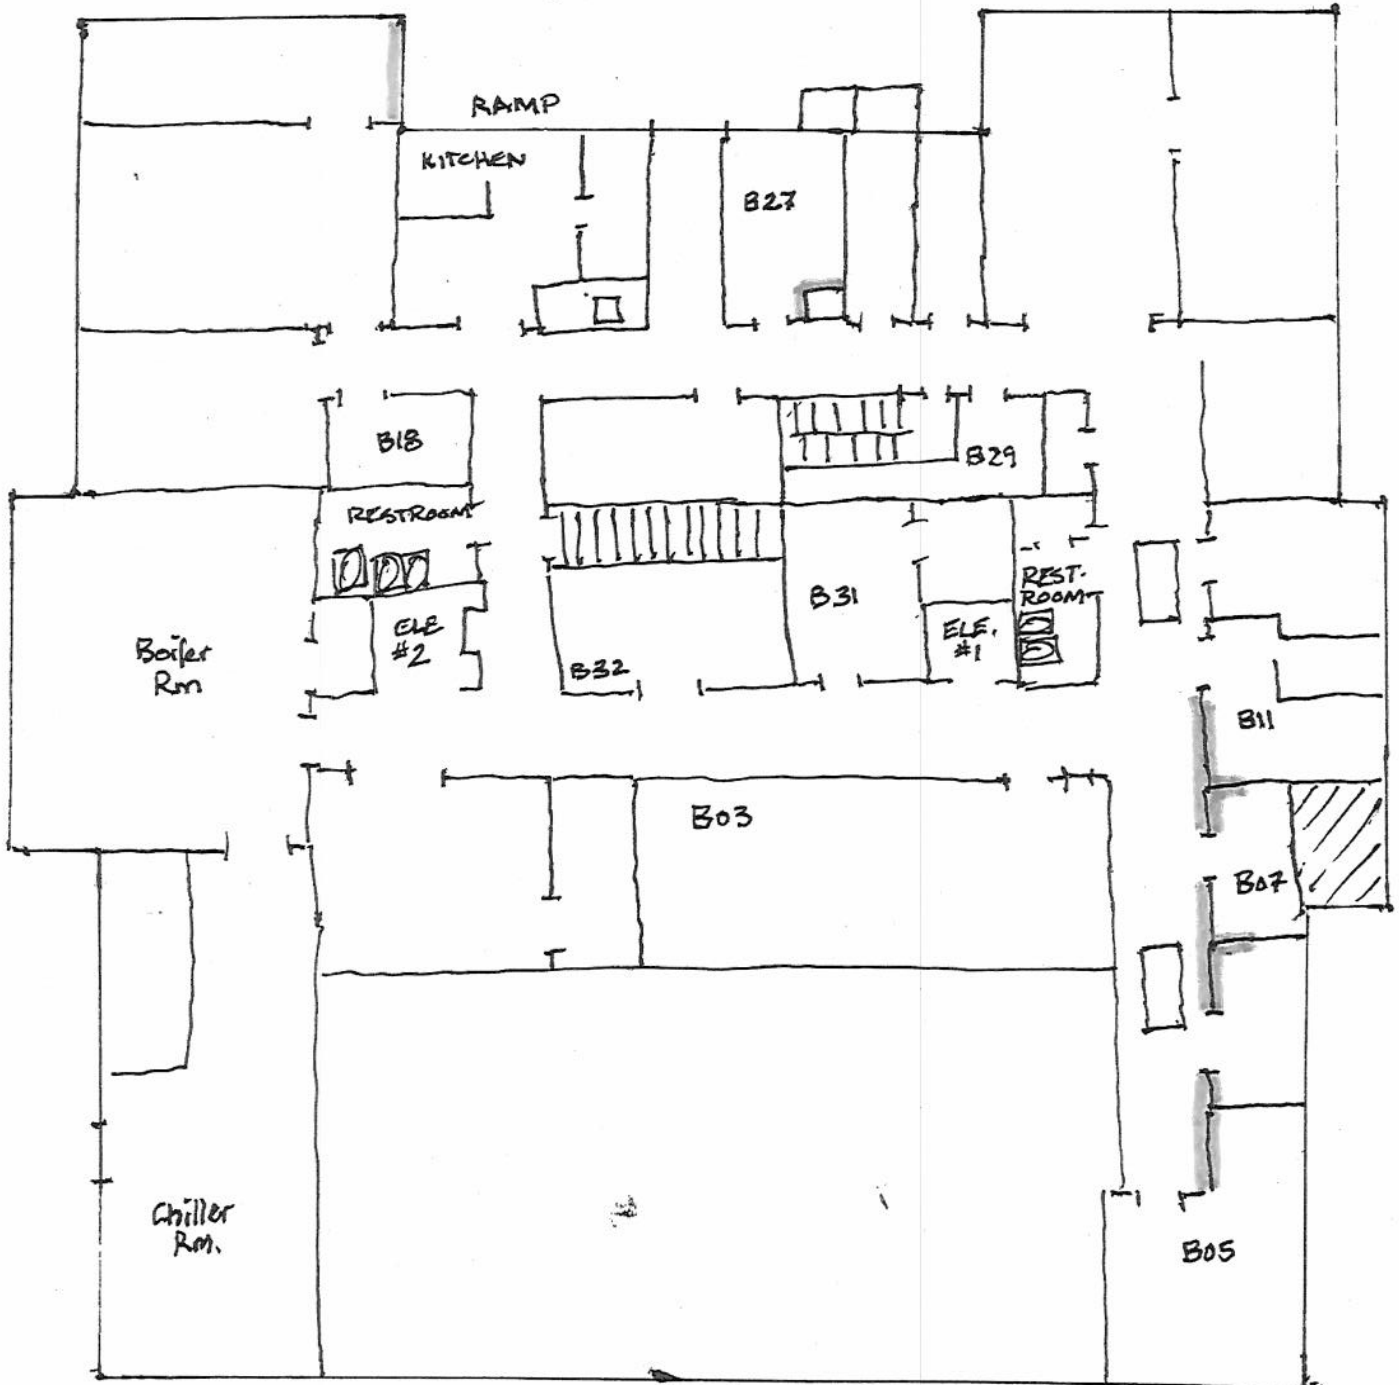
= GWB w/ elevated moisture content

POINT
OF ORIGIN

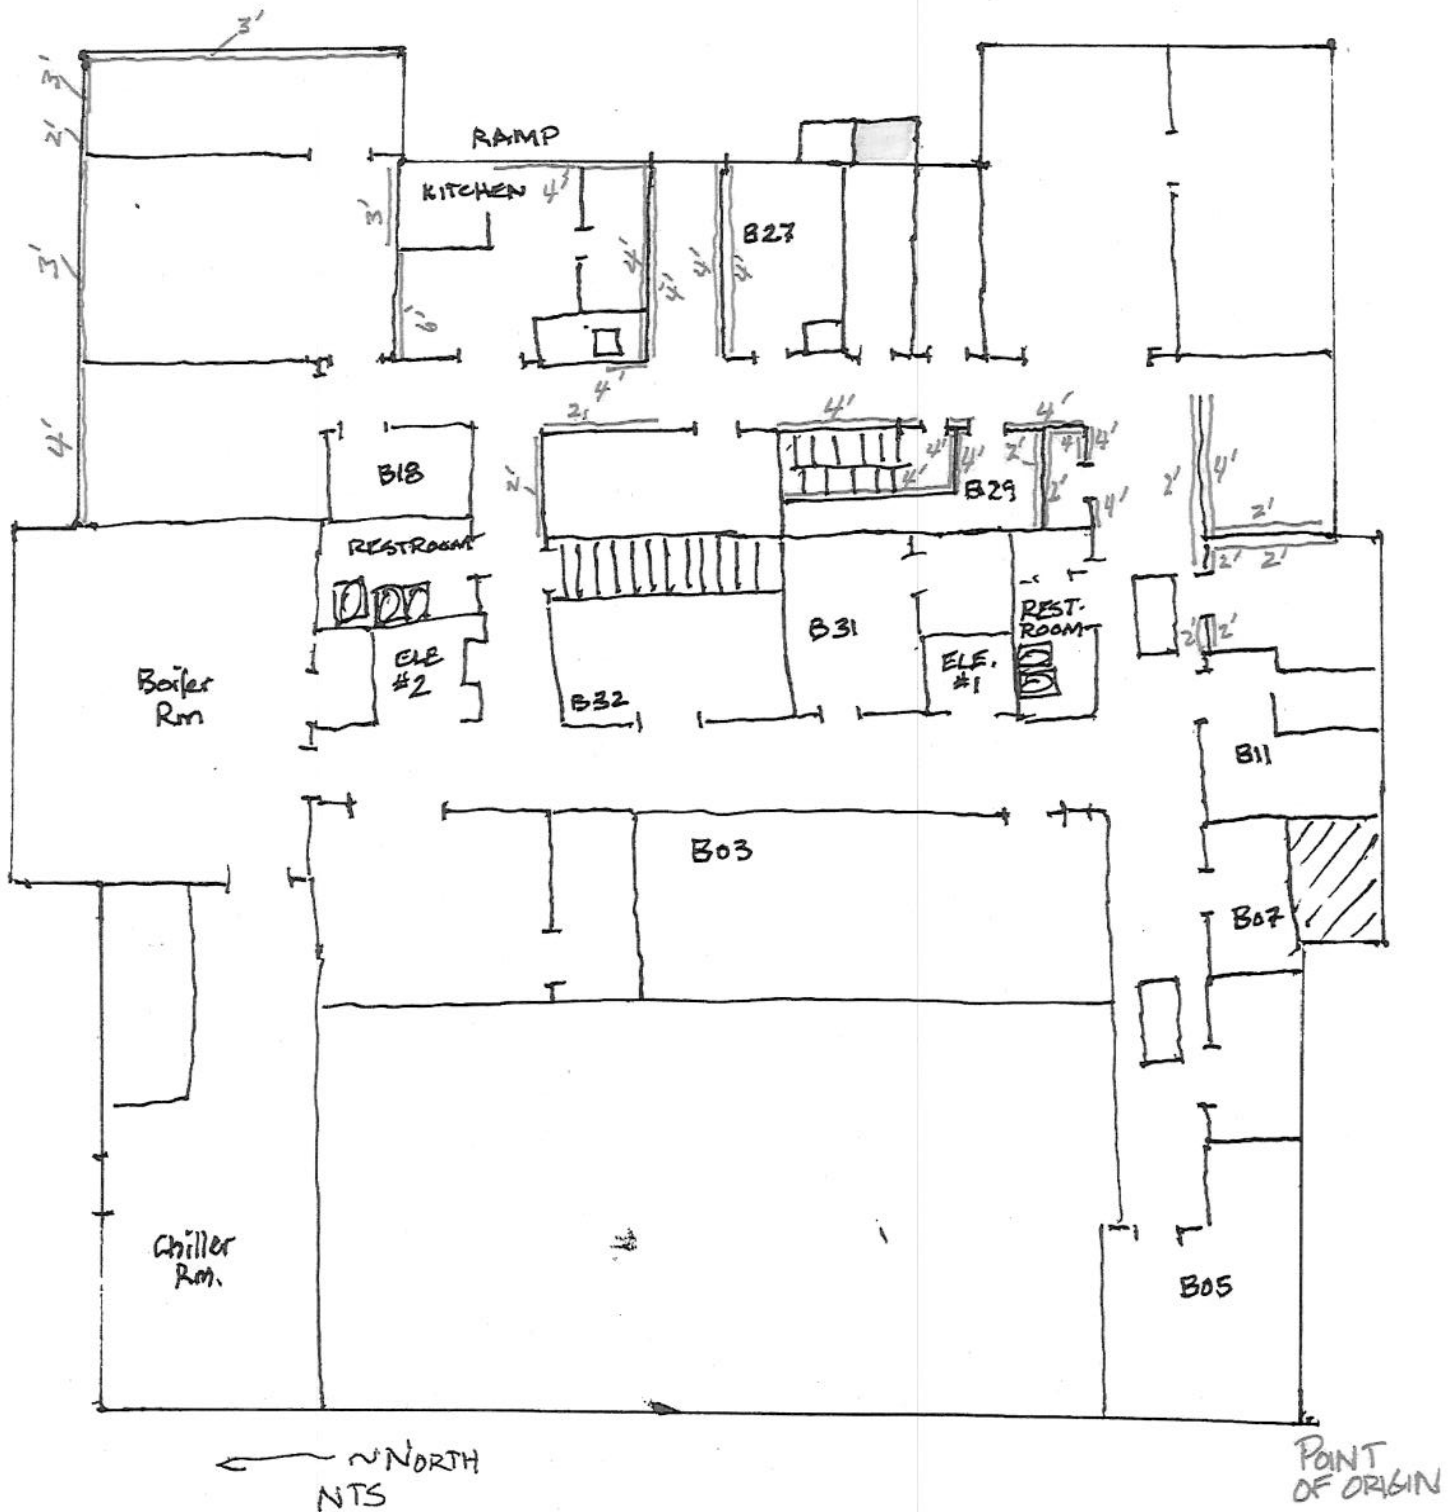
**PARTIALLY REMOVED GWB WALLS
2/11/09**

$\frac{1}{2} \cdot 2' = \text{area w/ removed GWS}$
 $\div \text{height of removal}$

= standing water in base of lift pit.

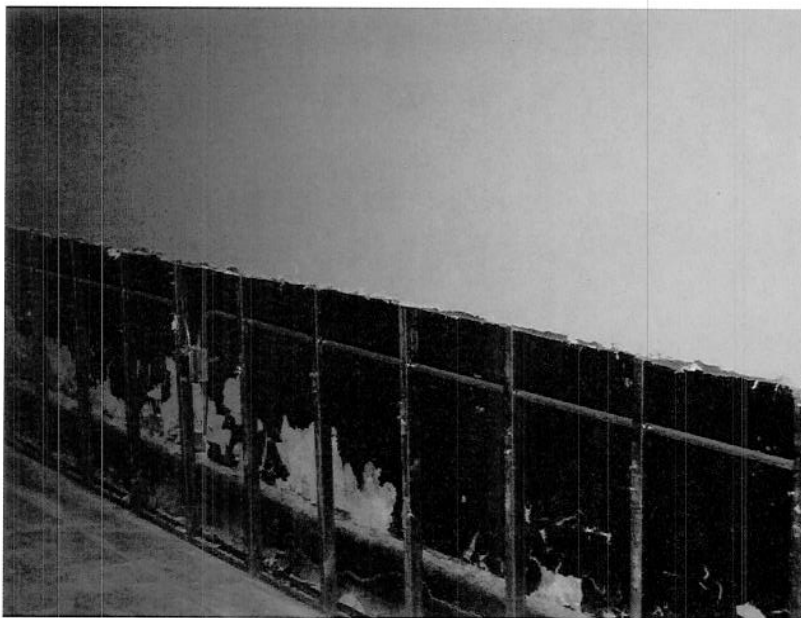
PHOTO #1: After EHSI pre-proposal walk-through but prior to this assessment, many lower GWB walls were removed to facilitate drying of wall cavities.

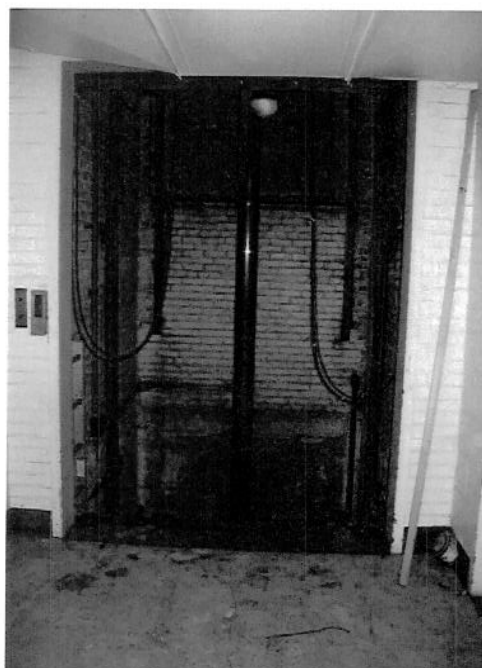
PHOTO #2: The bottom of this lift pit, located on the east side of the building near Room B27 had two inches of standing water. The water should be pumped out.

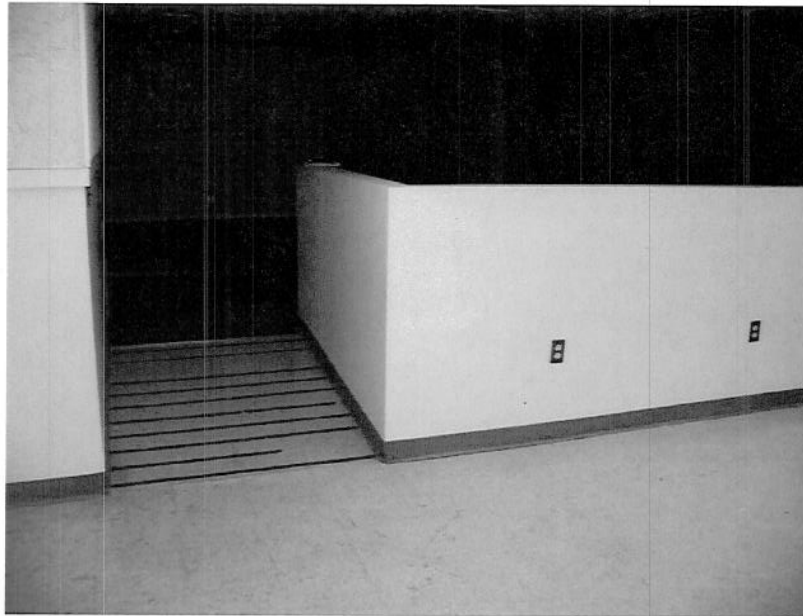
PHOTO #3 Room B11 had a partial raised floor. This room had a “musty” odor but the source was not identified. It is most likely beneath the raised floor (which is overlain with carpet tiles) or in the wall cavity shared with the corridor.

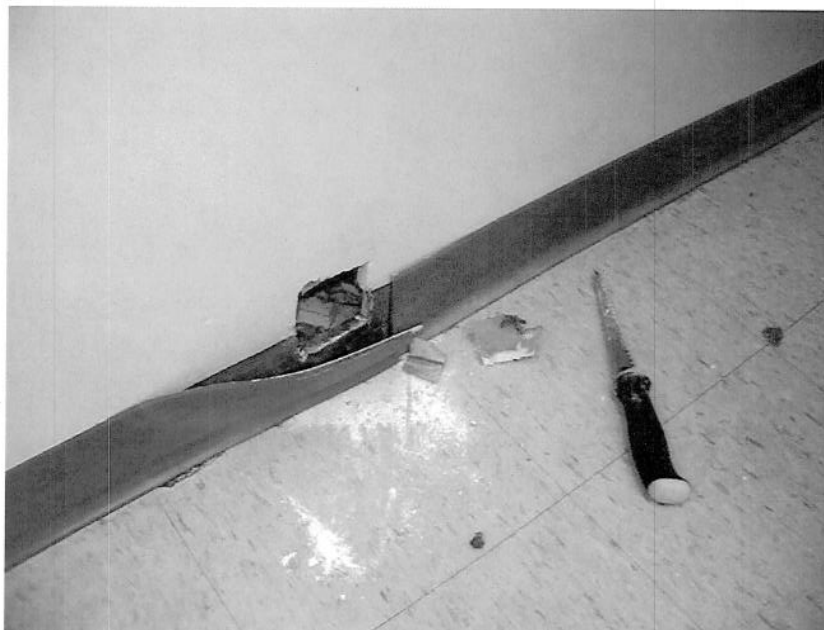
PHOTO #4: This enlarged access hole was used in an attempt to determine the condition of the floor beneath the raised floor in Room B11. The hole only allowed visual access of a limited area.

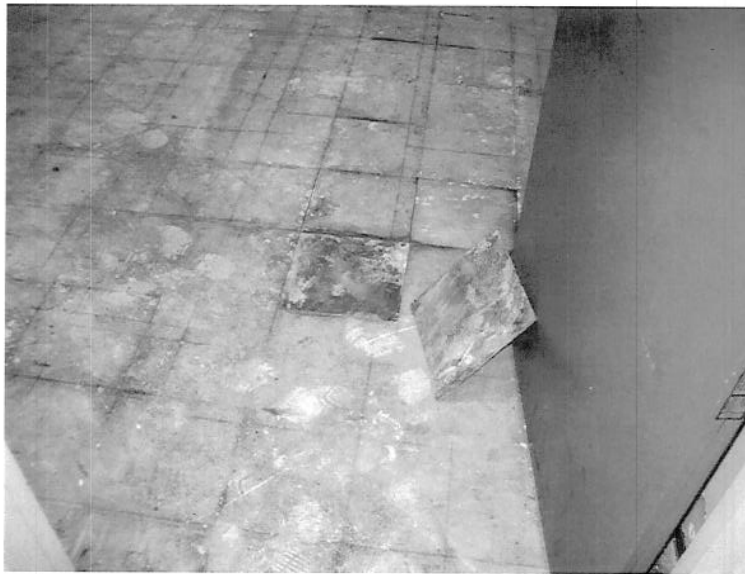
PHOTO #5: Flooring in Room B18. While it was apparent that flooring had been removed from the room, 12-inch square floor tiles still remained. Many of the tiles were cupped.

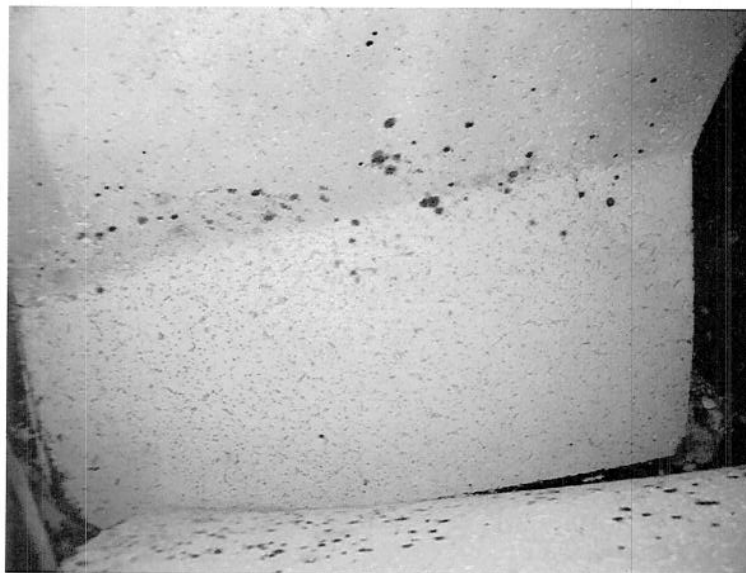
PHOTO #6: Minor mold growth on ceiling tiles stored in Room B29.

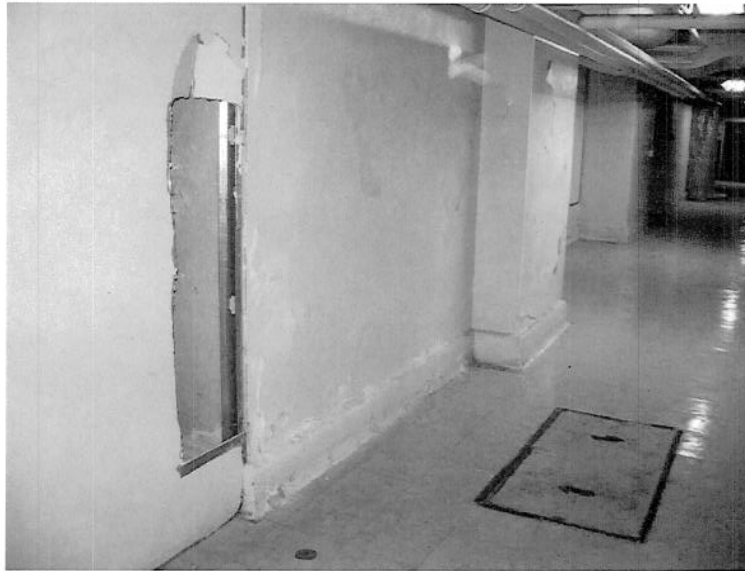
PHOTO #7: One of two access panels in the floor of the south hallway. The panel that was assessed had a steel plate covering a concrete vault. See also Photo # 8.

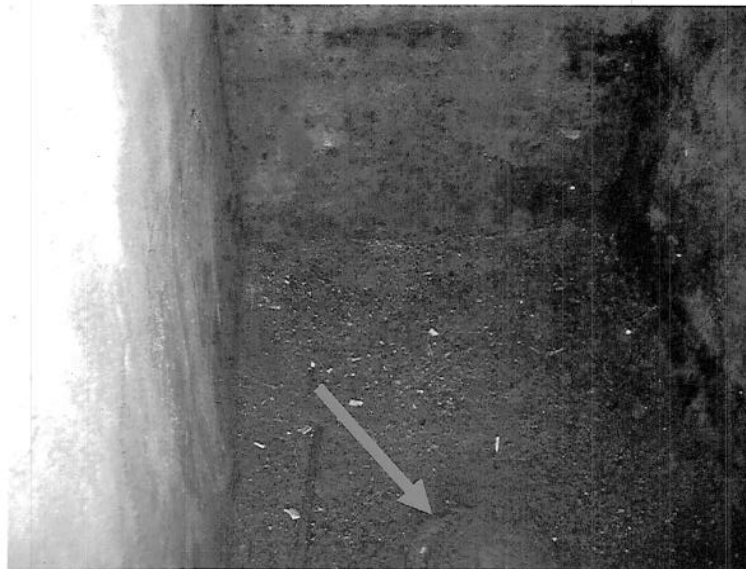
PHOTO #8: The hallway vault was concrete lined and had an approximately 5-inch diameter drain plug (red arrow) at the bottom. It was not an area of concern.

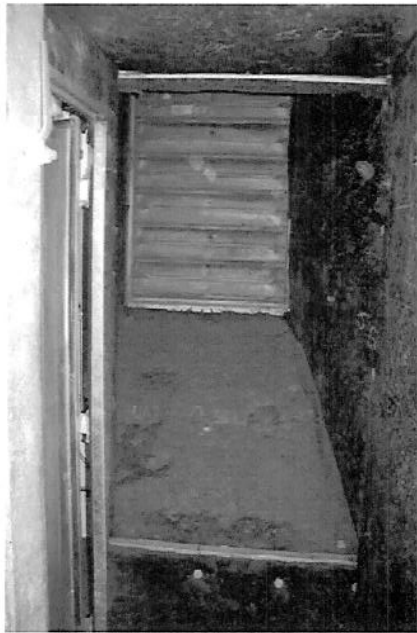
PHOTO #9: The outdoor air intake vent that was reportedly the point of entry from the water release at a frozen exterior wall hose bib.

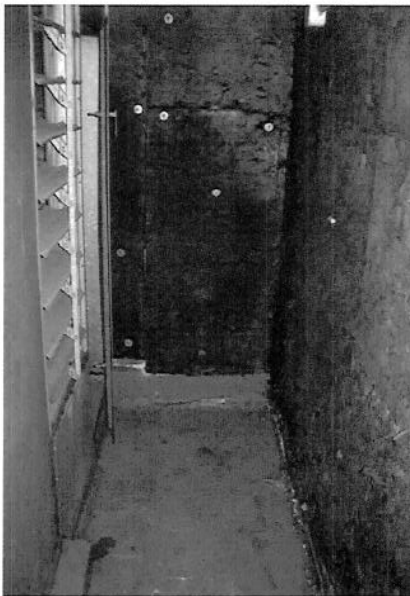
PHOTO #10: Inside the air handling unit near the reported point of entry. Note the condition of the liner. While some of the damage to the lower liner may have resulted from the water release episode, most of the discoloration and wear is due to service.

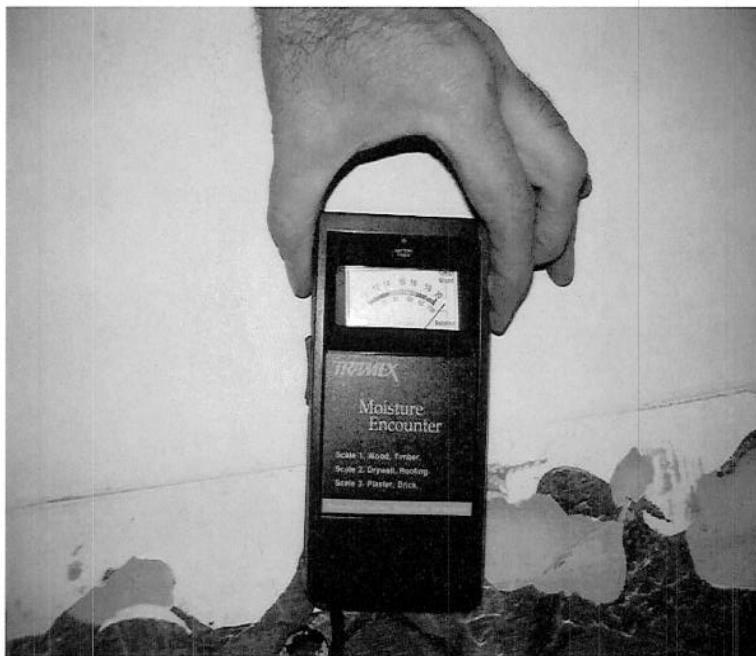
PHOTO #11: GWB with an elevated moisture content.
